USAAVLABS TECHNICAL REPORT 70-71A
ANALYSIS OF HELICOPTER STRUCTURAL CRASHWORTHINESS
VOLUME I

MATHEMATICAL SIMULATION AND EXPERIMENTAL
VERIFICATION FOR HELICOPTER CRASHWORTHINESS

January 1971

CONTRACT DAAJ02-69-C-0030
DYNAMIC SCIENCE (THE AVSER FACILITY)
A DIVISION OF MARSHALL INDUSTRIES
PHOENIX, ARIZONA

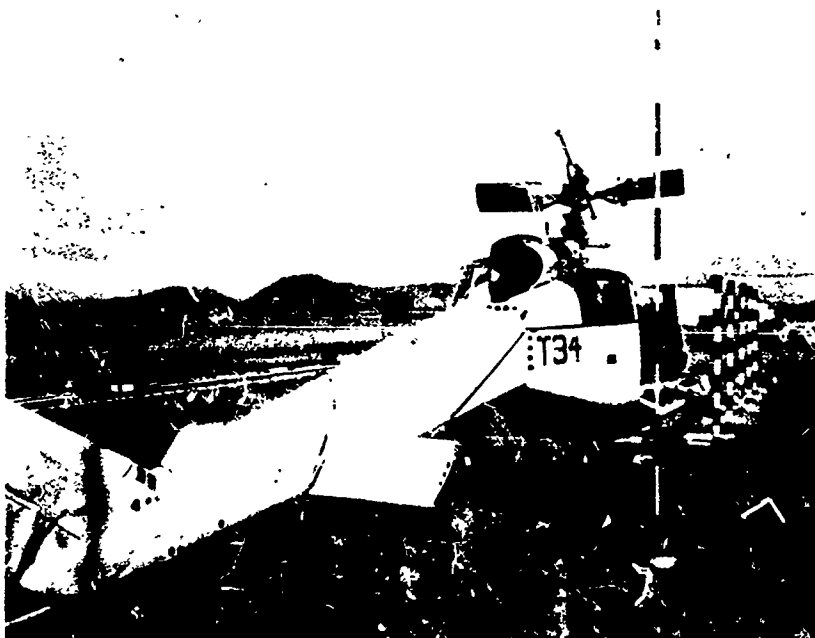
Figure 69. Final Position of Tail Boom.
